# A STUDY OF DEGRADATION OF PLATES FOR NICKEL-CADMIUM SPACECRAFT CELLS

## FINAL REPORT

JPL CONTRACT NO. 953649

TRW REPORT NO. 24118-6002-RU-00

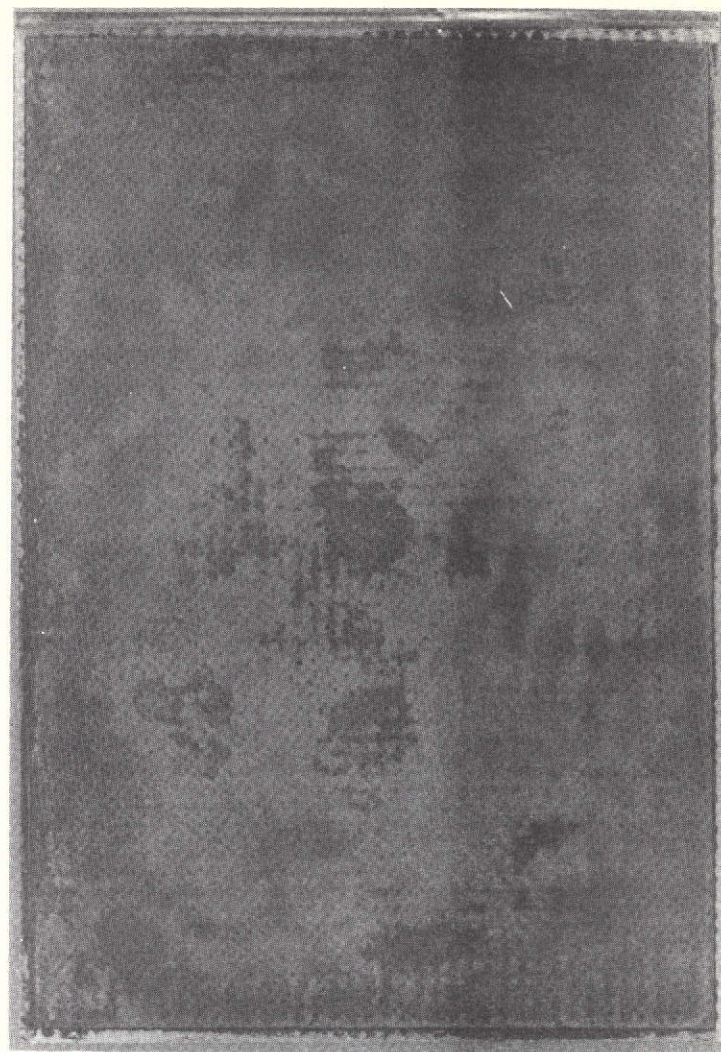
Figure 13. Type D Plate Photographs

B. Negative

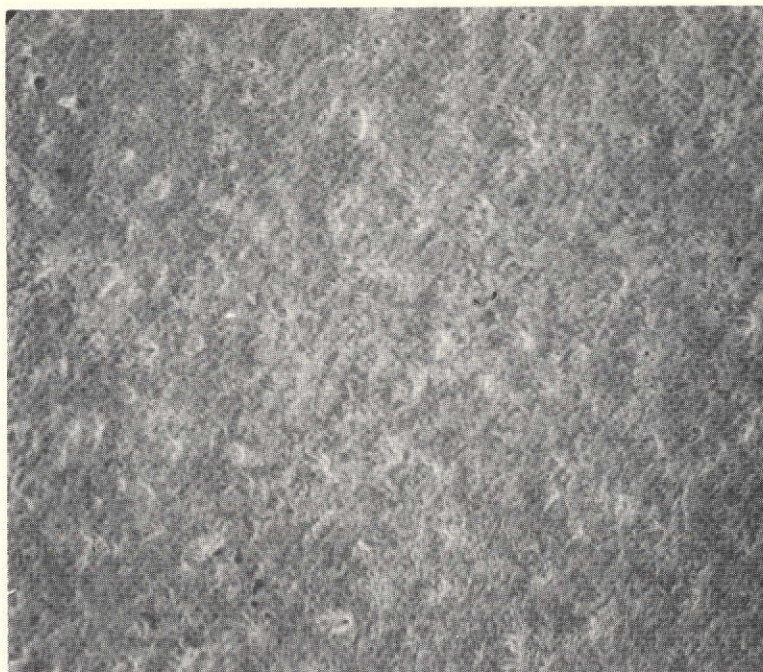
A. 100X

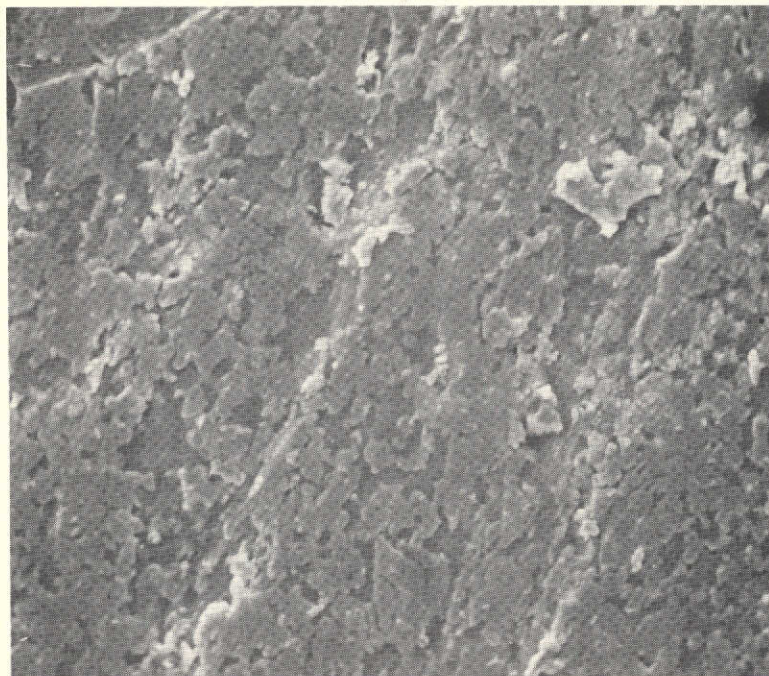
A. Positive Plate

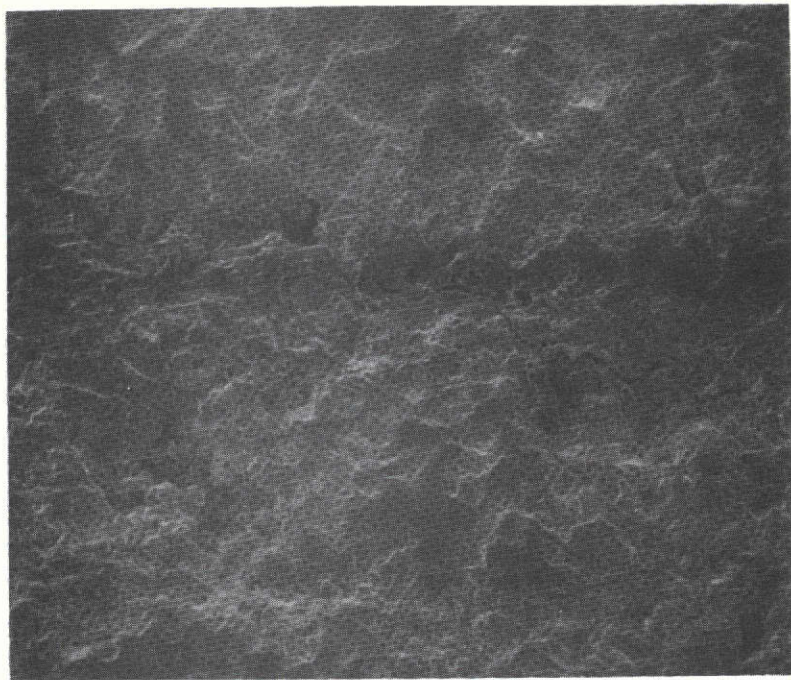
A. Uncoined

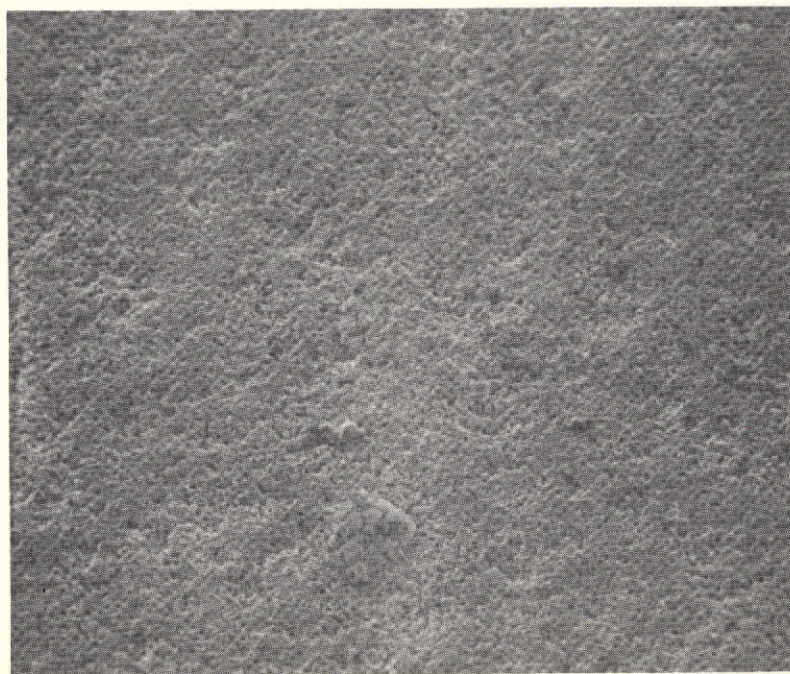
Figure 42. Type F Negative Plate - SEM 300X

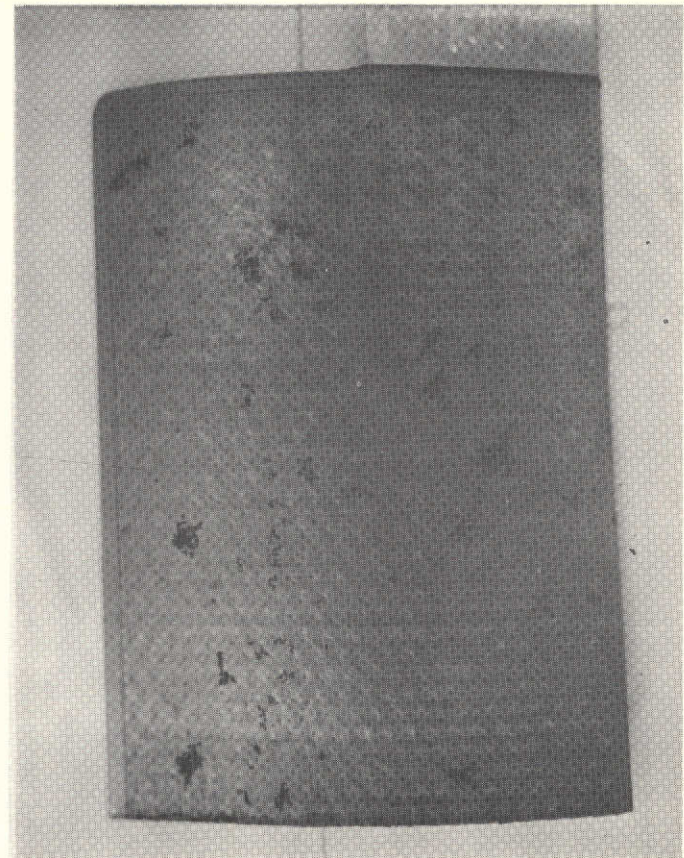
Figure 65. Type A Positive Plate After Accelerated Testing

Figure 65 shows the sides of the two Type A plates that faced each other in the cell. The active (uncoined) area shows many tiny pits and blisters. The coined edges along the sides are in good condition. The uncoined edge at the bottom of the same plate, as shown in Figure 66, was disrupted by swelling and cracking. Figure 67 shows a more enlarged, edge-on view of another portion of the uncoined edge after testing, showing evidence of attack at the cut face.

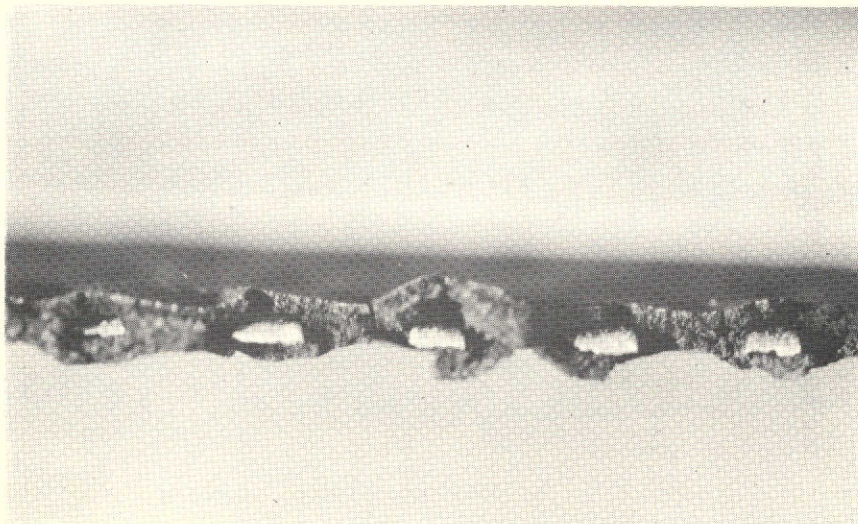
Figure 71. Type B Positive Plate - Closeup of Bottom Edge  
After Accelerated Testing 10X

Photographs of a representative Type B (uncoined) plate after accelerated testing are shown in Figures 70 and 71. Note that the main area of the plate appears unchanged, but that the edges were attacked. The closeup edge view in Figure 71 illustrates the type of swelling and separation from the grid that occurred along the uncoined edges of this material.

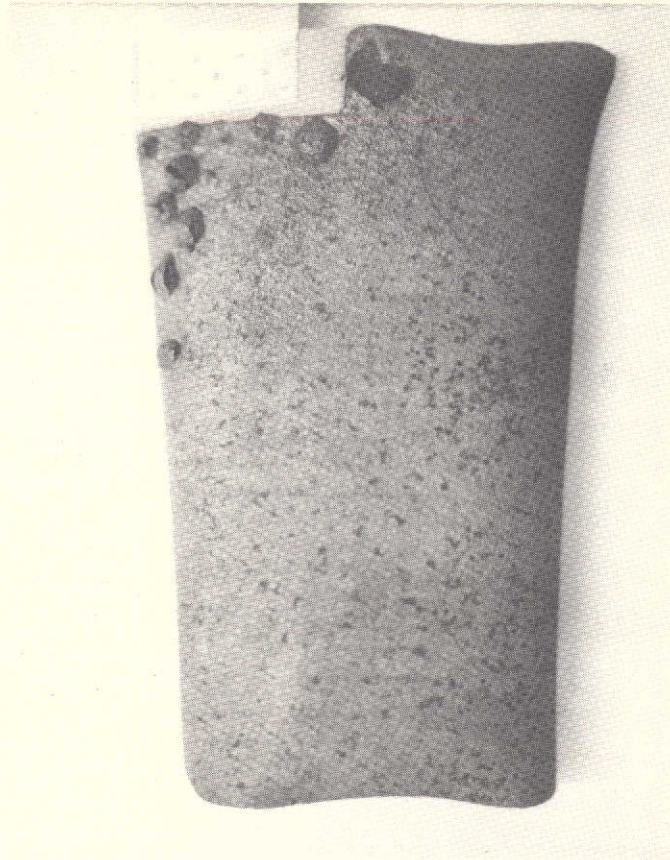
Figure 77. Type E Positive Plate After Accelerated Testing

Type E positive plates after accelerated testing are shown in Figures 76, 77 and 78. These plates were badly curled, due to the fact that they are made with almost all the sinter on one side of the screen grid, and hence all the expansion takes place on that one side. Note the large blisters near the tab of one plate. The close-up view of a coined edge shows that although expansion and cracking of uncoined material

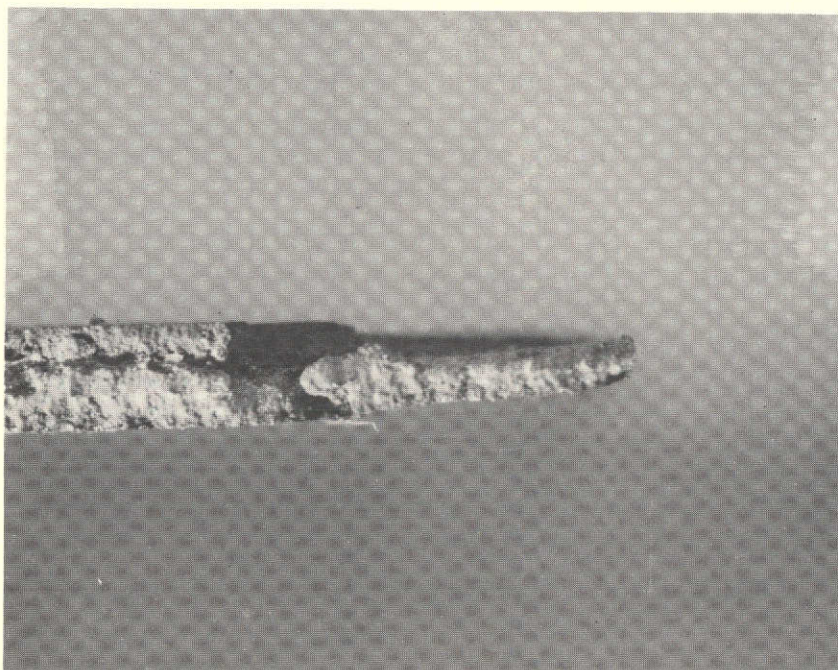
Figure 89. Type A Plate - Profile of Trimmed Coined Top Edge (Some Taper Remaining) (10X)

Cross-sections taken through the top cut edge on two different Type A positive plates in the as-received condition are shown in Figures 88 and 89. Figure 88 shows no appreciable taper near the edge, while Figure 89 shows part of the original taper remaining at the edge. Note in Figure 88 that the coining indentation occurred on one side of the plate only.

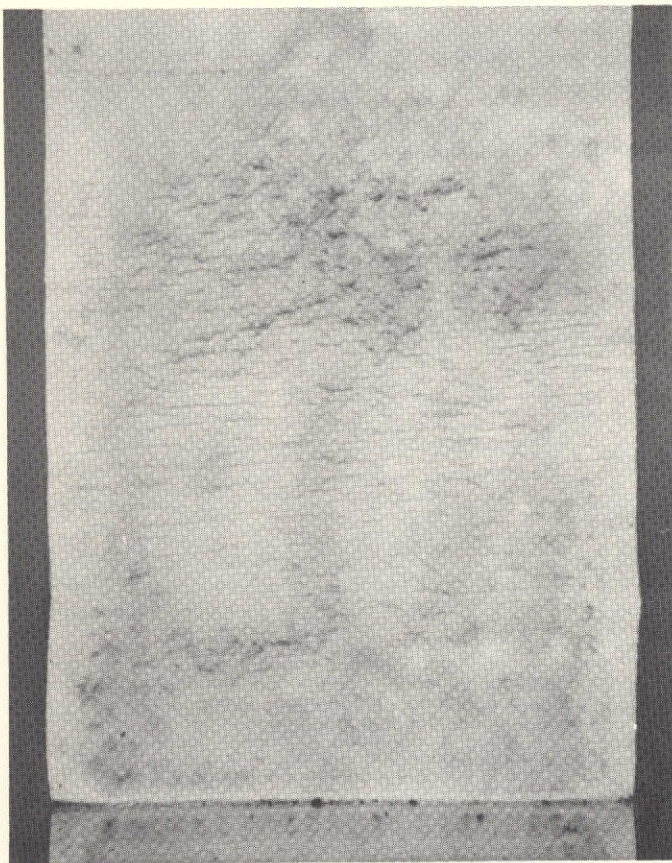
Figure 93. Separator From Type B  
Sealed Cell - Side  
Facing Positive Plate

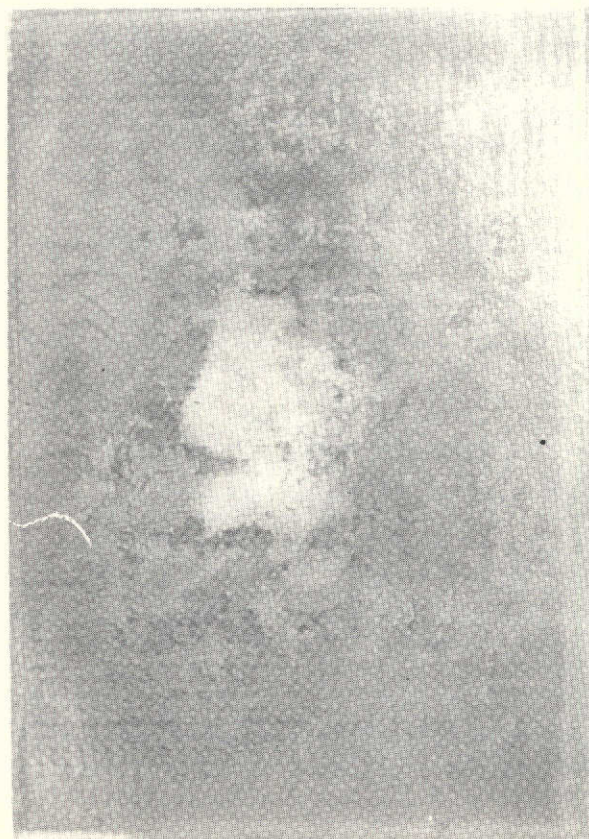
Figure 98. Type D Negative Plate  
After Sealed Cell Test

All the Type D plates appeared in good condition, as seen in Figures 97 and 98. However, cadmium active material was deposited on the surface of some of the separators in contact with the negative plates.

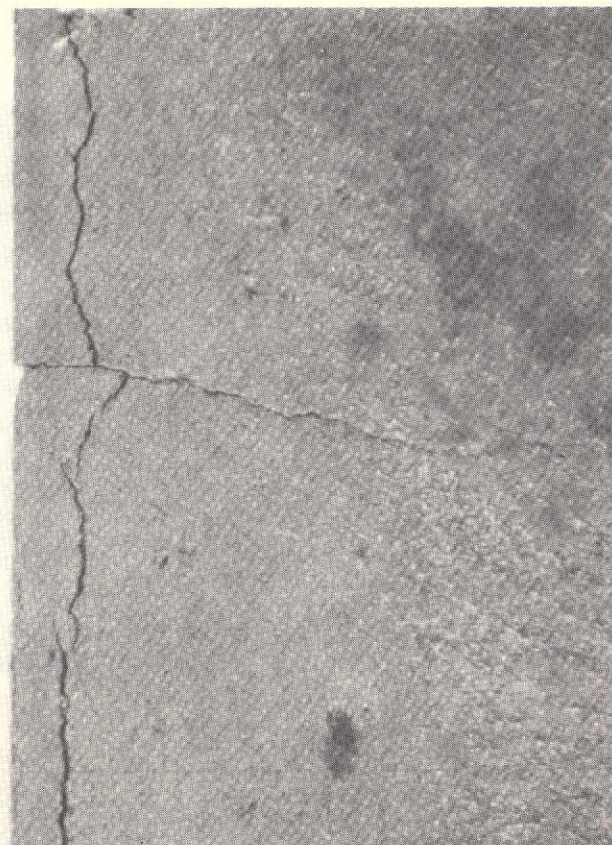
Figure 100. Type E Positive Plate  
Crack Near Edge (5X)

The Type E plates were generally in good condition, Figure 99, including the uncoined edge at the bottom. No appreciable material was seen in the separators. Several of the negative plates had relatively large cracks, near the top and bottom edges running parallel to these edges, as shown in Figure 100. The nature of these cracks was different from those produced in positive plates by cycling, and it is postulated that they occurred when the negative plates, being somewhat warped when received, were compressed and flattened during cell assembly.

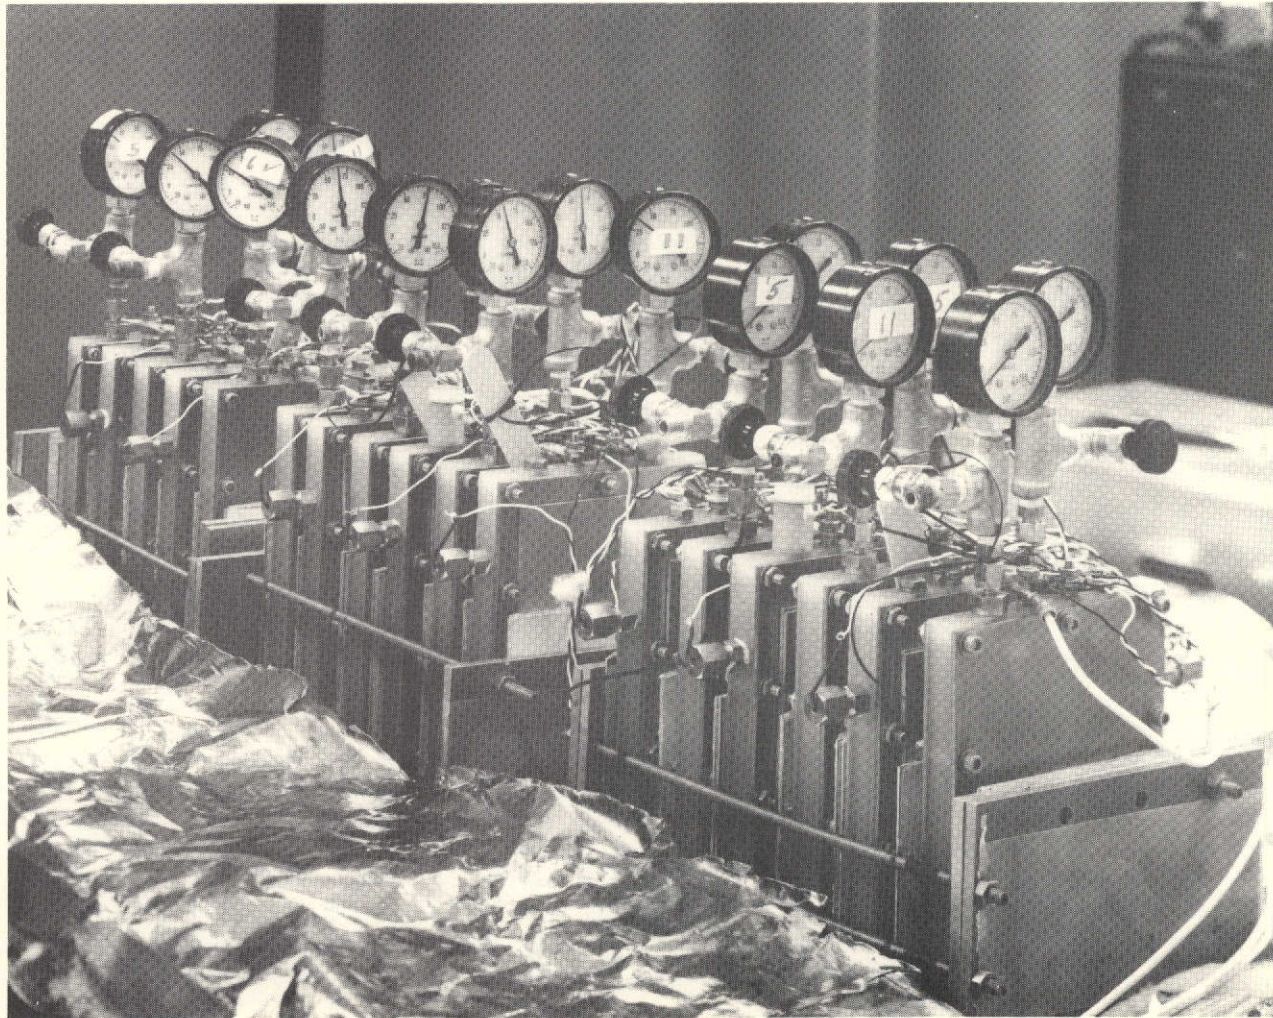
Figure 105. Reusable Cells on Test

The total active positive plate area of these cells (7 positive plates @  $0.69 \text{ dm}^2$  per plate) was  $4.82 \text{ dm}^2$ . When new, the capacity delivered to 1 volt was  $13.5 \pm 0.25$  ampere hours when discharged at 6 amperes. Charge current was nominally 1.5 amperes during cycling. Each group of three cells was operated as a series unit with a separate charge and discharge control circuit. The controller imposed a charge voltage limit, at which point the 3-cell unit went into a constant voltage charge mode. The limit was initially set at 1.48 volts/cell at  $25^\circ\text{C}$  and 1.52 volts/cell at  $0^\circ\text{C}$ . A photograph of a group of these cells on test is shown in Figure 105.
